# **CORROSION BEHAVIOR OF MILD STEEL IN HIGH pH AQUEOUS MEDIA**

**Prepared for:  
NRC Contract No. FIN A-4171-9  
U.S. Nuclear Regulatory Commission  
Office of Nuclear Material Safety  
and Safeguards  
Washington, DC 20555**

**September 1989**

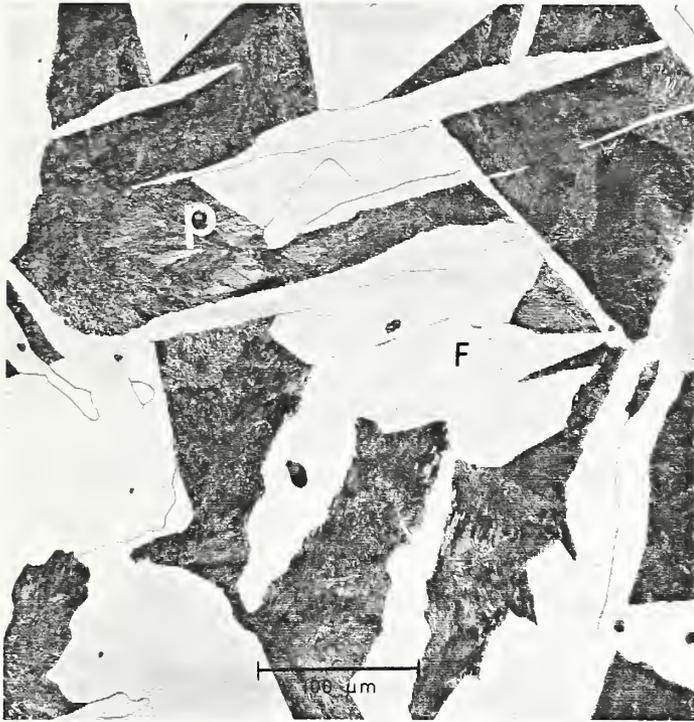
Figure 1. A-27 Steel, uncorroded

Examples of the microstructure of an uncorroded specimen are shown at two different magnifications in the micrographs of Figures 1 and 2. This microstructure consists of areas of ferrite (labeled f) and pearlite (labeled p). After anodic polarization, the specimen surface becomes uneven and three dimensional in appearance due to the corrosion attack on the surface. The pearlite is attacked more severely than the ferrite, as shown in Figure 3. Pearlite consists of alternating layers of cementite,  $Fe_3C$  and ferrite. The cementite is cathodic to the ferrite, and this promotes enhanced attack of the ferrite contained in the pearlite. Areas of local attack that could be identified as pits, are shallow and crystallographic, but are not deep pits in the usual sense of the term. Figure 4 shows that these areas also are present after cathodic polarization.

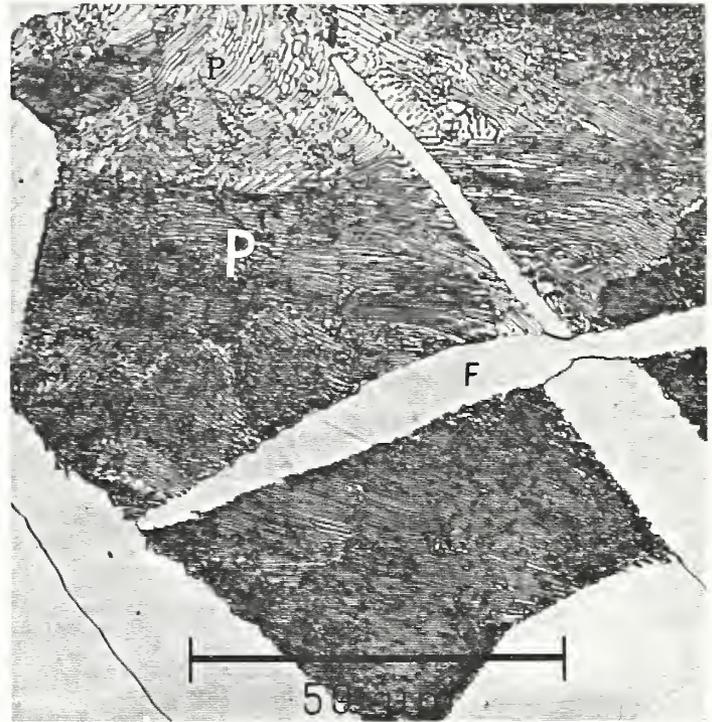
Figure 2. A-27 Steel, uncorroded

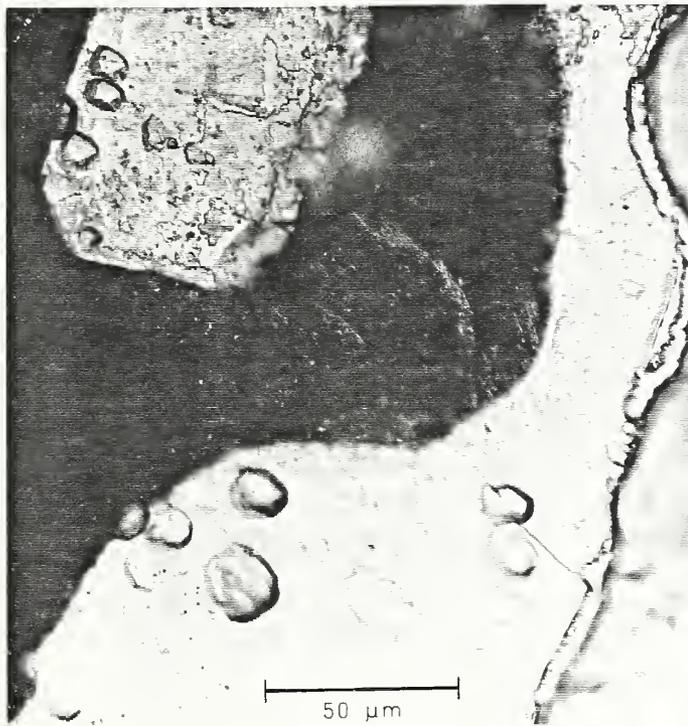
Figure 3. A-27 Steel, after anodic polarization

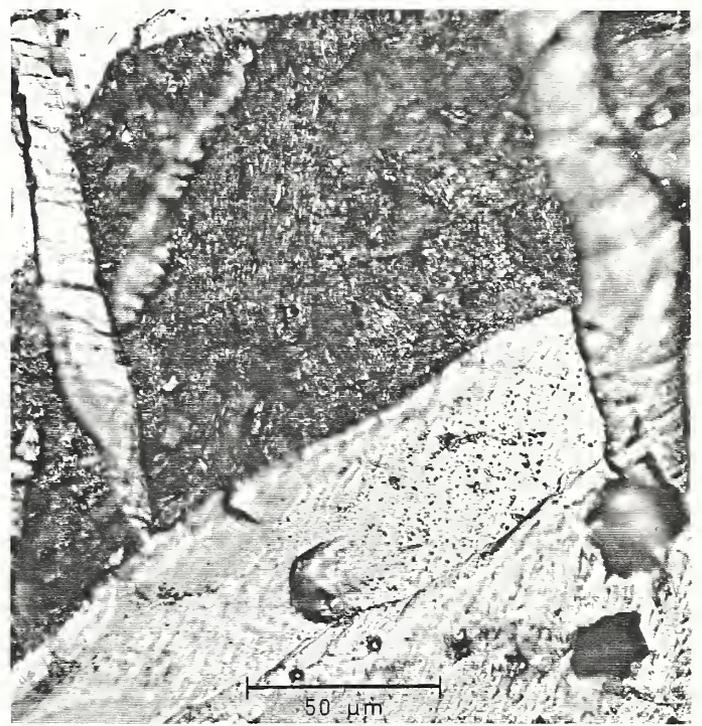
Figure 4. A-27 Steel, after cathodic polarization

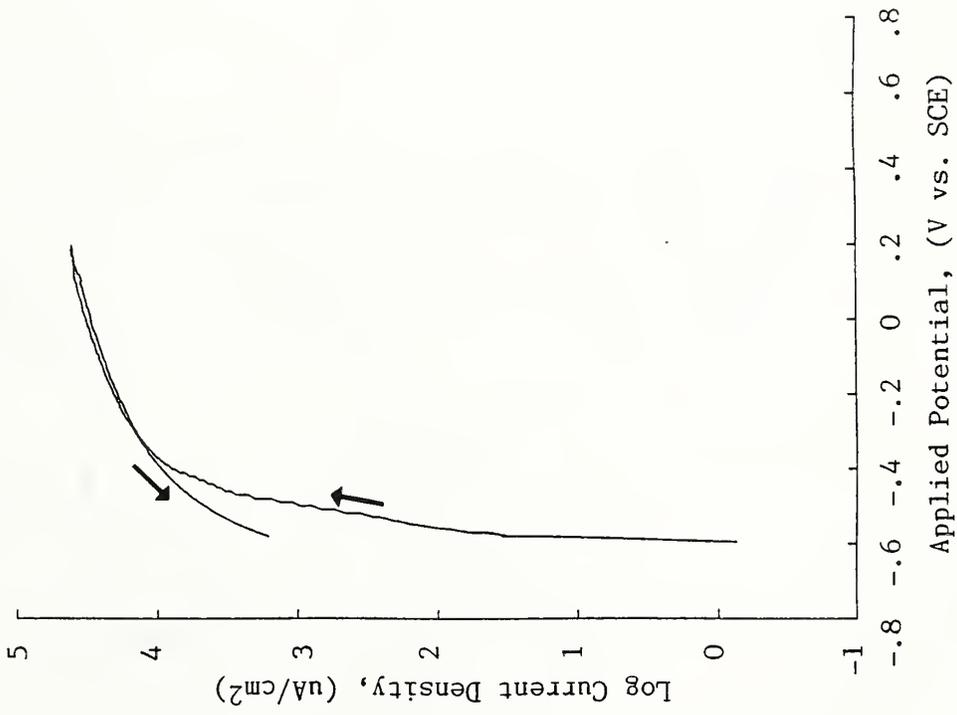
Figure 5. Anodic polarization curve; A-27 steel in 95°C GR-4 water with a pH of 9.75

An example of a cyclic anodic polarization curve is shown in Figure 5 where the log of the current density is plotted versus the applied potential. These measurements were taken by starting at the corrosion potential. This is an example of the test labeled "A" in Table 6. Arrows on the curve indicate the direction of the applied potential during the test.

This curve shows that no passivation occurred and that the current density increased from the beginning. The current levels off somewhat at high currents at approximately 0.30 V due to the presence of a thick film which limits diffusion. Diffusion of the metal cations (outward) and of oxygen anions (inward) plus any other diffusion of electrons or lattice defects is necessary for the film to grow and to prevent polarization. Such thick films can offer some protection unless the films fall off. This film was observed to break up and fall off in some of the tests, causing sudden rises in the current.

In these tests represented by Figure 5, the reversal of the potential does not show a hysteresis in the current. The increased current in the remaining portion of the curve may be due to increased specimen area as a result of the corrosion during the test.

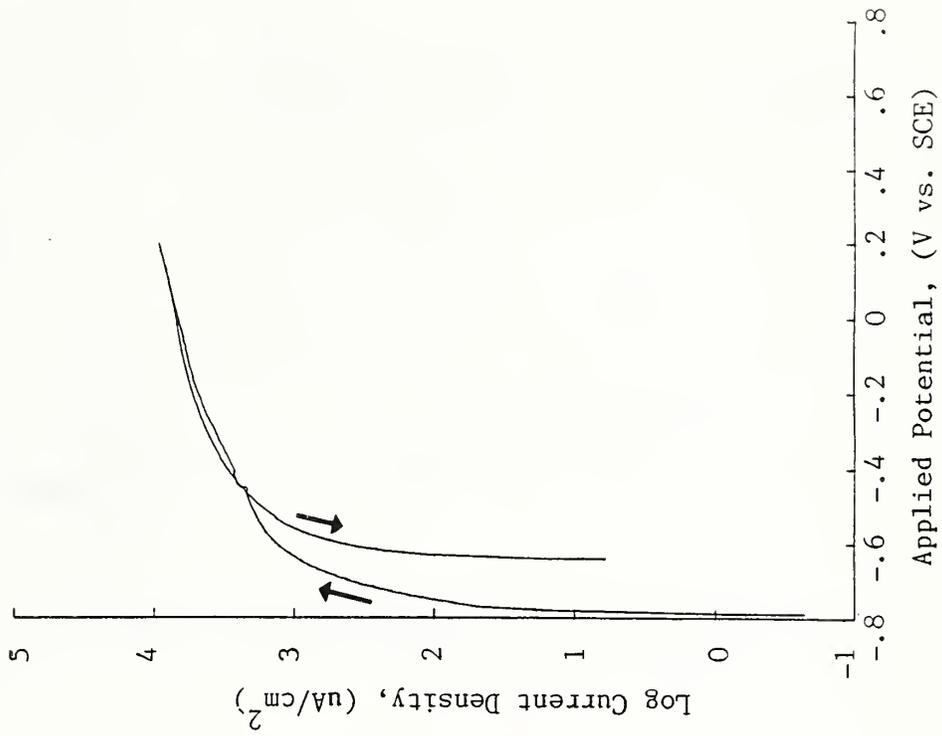
Figure 6. Anodic polarization curve; A-27 steel in 95°C GR-4 water with basalt and bentonite with a pH of 8.3

Figure 6 typifies a cyclic anodic polarization curve for the test represented by "B" in Table 6. In this test, measurements also were started from the corrosion potential. This curve starts from a lower corrosion potential when compared with that of Figure 5 and also shows that no passivation occurred. Here, as in the test of Figure 5, with increasing applied potential, the current becomes relatively constant at a potential of approximately 0.60 V due to the formation of a thick film and limited diffusion. The current, for the remaining portion of the curve, is different from that of Figure 5. It is lower. This may indicate increased protectiveness of the film or some reaction of the film with the basalt, bentonite and water mixture.

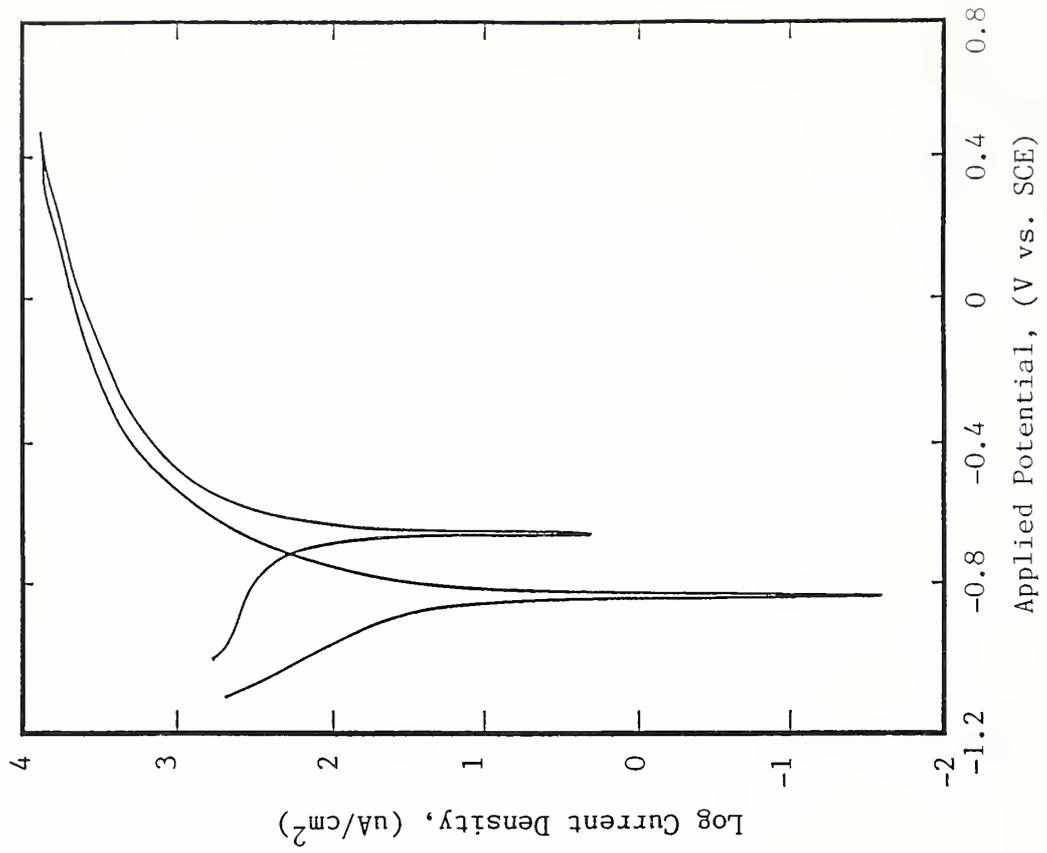
Figure 8. Cyclic polarization curve; A-27 steel in 95°C J-13 water with a pH of 8.5

Figure 8 is a cyclic polarization curve for A-27 steel in J-13 water at 95°C and a pH of 8.5. The initial corrosion potential,  $E_{c_i}$  is more noble than the initial corrosion potential in the Grande Ronde 4 water, and the final corrosion potential is essentially the same. There is no hysteresis in the case of the J-13 exposure, and current on the return portion of the cycle remains lower than on the initial curve. The levels of  $Na^+$  and  $Cl^-$  are less in the J-13 water, and the pH is lower than that of the Grande Ronde 4 water.

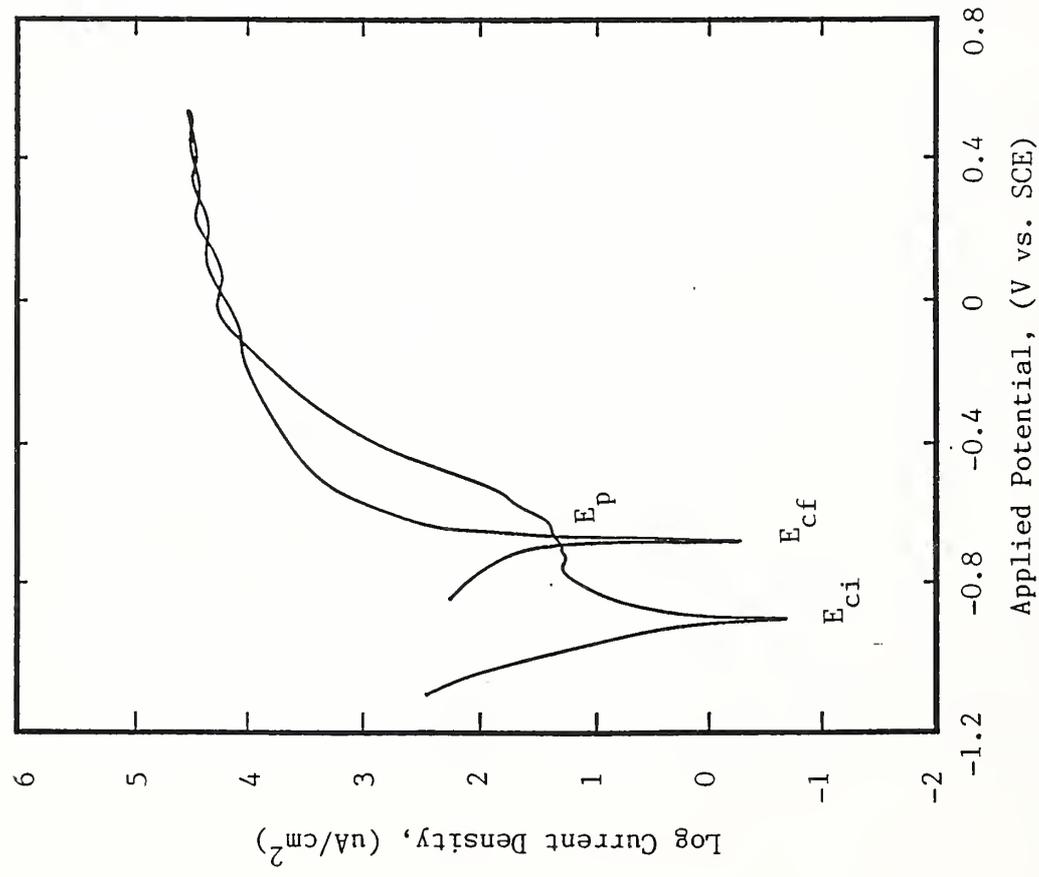
Figure 7. Cyclic polarization curve; A-27 steel in 95°C GR-4 water with a pH of 9.75

Figure 7 is a cyclic polarization curve for A-27 steel in Grand Ronde 4 water at 95°C and a pH of 9.75. These data were taken at a faster rate of applying the potential than that used for Figures 5 and 6, and measurements were started at -0.30 V less noble than the corrosion potential. The results of both sets of measurements are similar. There is no hysteresis in the beginning portion of this curve but the current remains high in the later portion of this curve. This hysteresis in the later portion may be due to the rate at which the potential was applied or it may be due to increased localized corrosion. The protection potential (indicated by  $E_p$ ) and the final corrosion potential (indicated by  $E_{c_f}$ ) on the return curve, both are noble to the initial corrosion potential (indicated by  $E_{c_i}$ ). Data of this type should be used with care and effects of environmental and testing parameters should be carefully established.
